APPENDIX B

Locations used for Emergency Discharges

Pump A - East St, Hambledon - Overpumping and Tankering Sites (Sheet 1 of 8)

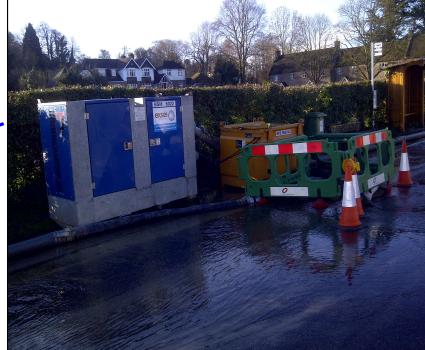
Pump C - West Street, Hambledon - Overpumping Sites (Sheet 3 of 8)

Vicarage Lane The Gardens Camera Tanker angle of view Point for adjacent (MH5002) photograph West Street Overpump (MH6005 to MH5002) Pump C (464547, 115008) Opposite The Gardens 6 inch pump from MH5002 to MH3902 (See photograph)

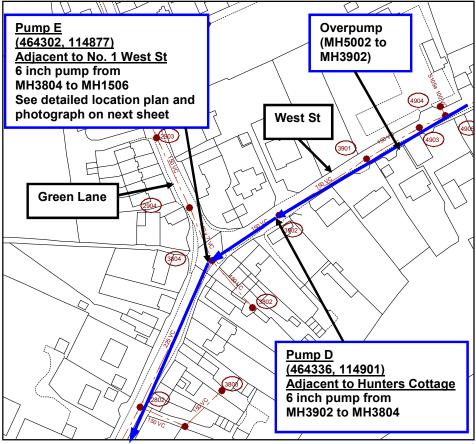
Pumps D and E - Junction of Green Lane and West Street, Hambledon - Overpumping Sites (Sheet 4 of 8)

Green Lane West Street (subject to traffic management at junction) Camera angle of view for adjacent photograph Hose from MH3902 Pump E Hose to (464302, 114877) MH1506 6 inch pump located close to pedestrian island in Hose crosses westbound carriageway **West Street** (closed to traffic) lifts flow beneath from MH3804 protective ramp (See photograph)
